Overview of Section D

The present church of St. Paul's, Bow Common

Repairs and revelations:

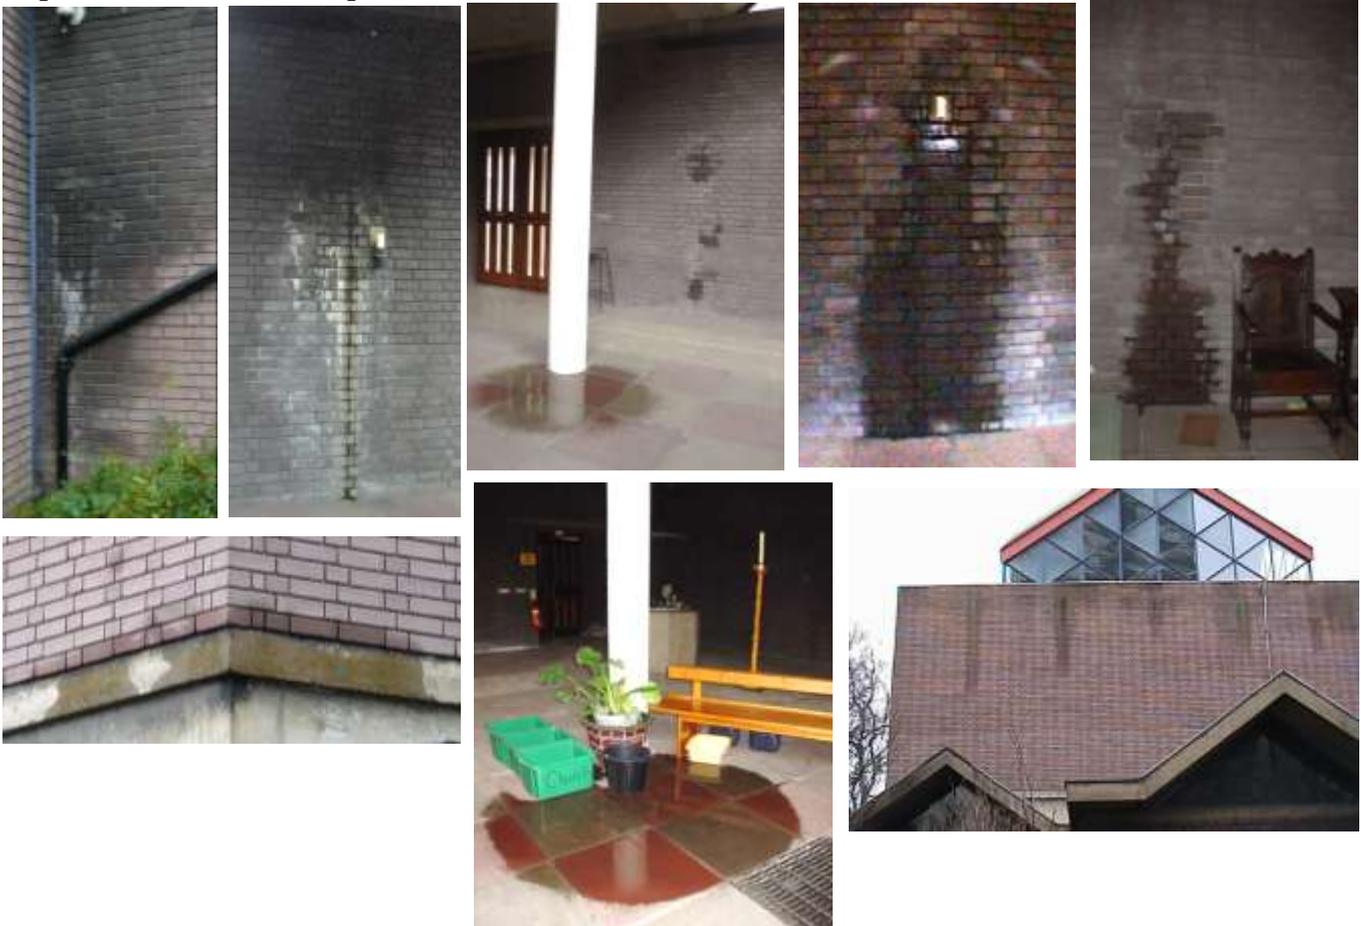
These views of the church show what was common every time there was even modest rain. The church raised funds for repairs and the project was called the 'Drop in The Bucket' Appeal! Strategically placed buckets were a permanent feature of church furniture up to 2005 when effectively a new roof was put on the church and buckets could finally be removed! See later in this account.

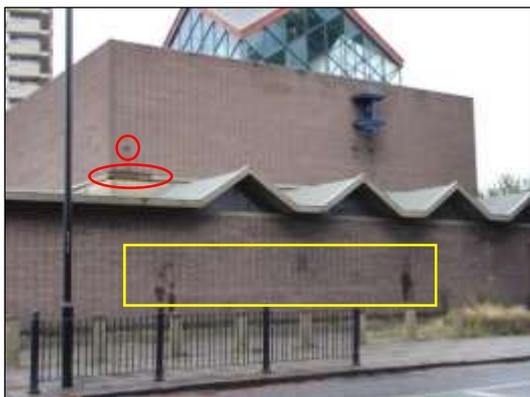
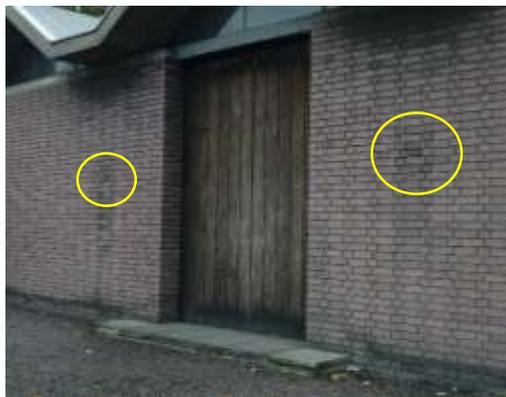
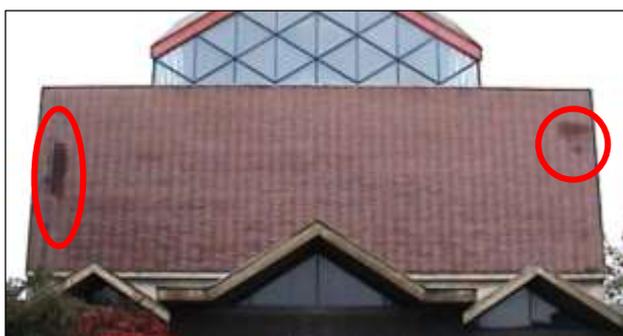
These views show (yellow) lower level leaks and (red) higher level leaks. At the lower level there seemed to be a regular height and regular interval, both inside and out, to the leaks. But what was inside the walls that could be leaking into the brick?

At the upper level, leaks seemed to be occurring along the vertical extent of the corners of the upper brick 'box' of the church.

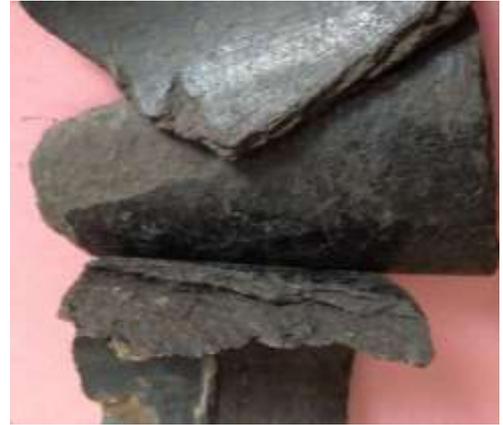
'as they arise. Pitch fibre will 'squash' over time.' The principal cause of failure in pitch fibre pipes is as long term creep failure of the material. This phenomenon is normally caused by point loading from hard objects due to poor construction; or loss of side support. Pitch fibre pipes are also highly susceptible to damage by high pressure water jetting.' Documented 2003

The images shown here are of pieces of pitch fibre drains replaced in a section to the south of the church hall in 2001.

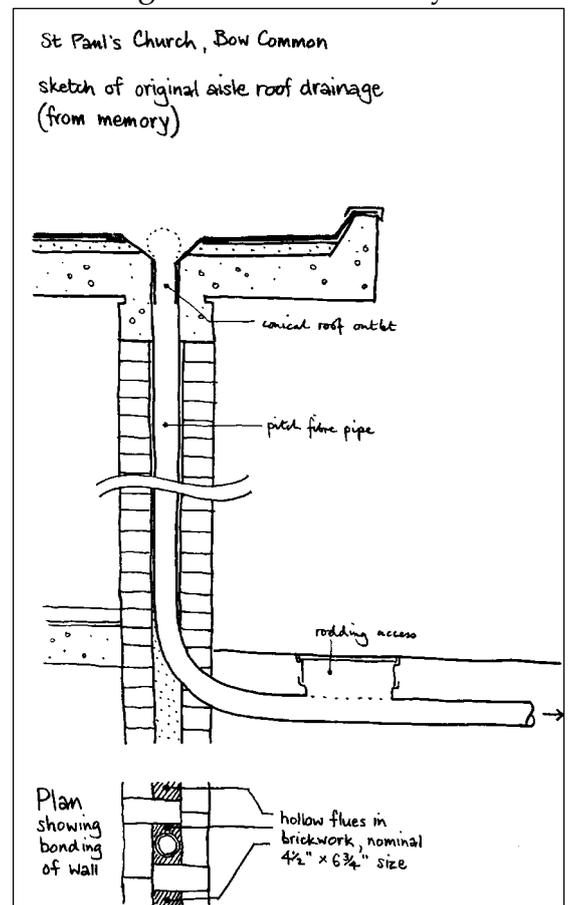
In the course of our correspondence, in March 2001 Maguire sent me the diagram shown here to the right which indicates (from his memory) his design for continuous lengths of pitch fibre pipe sealed into the walls with an easy bend at the bottom to connect into the circuit of external drainage pipes also in pitch fibre. There is no indication at all of any internal joints in the pipes. His conclusion therefore was that the pipes were leaking at the seal on each pipe at its upper end where it meets the aisle roof above. He was unaware of what the builders had actually built.

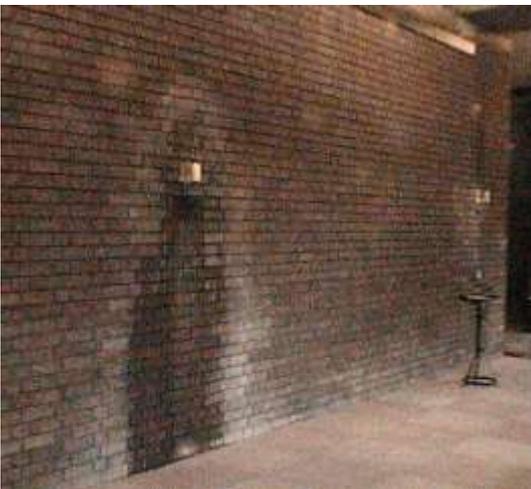
On May 24th 2001, after permission had been granted, another approach was tried out on the most heavily leaking downpipe on the north wall of the church (shown here).

For the first and only time since 1959 a length of down-pipe was now visible and, indeed, there were two lengths of pitch fibre pipe joined by a close-fitting but loose collar. The builders truly had disregarded the architect's wishes!

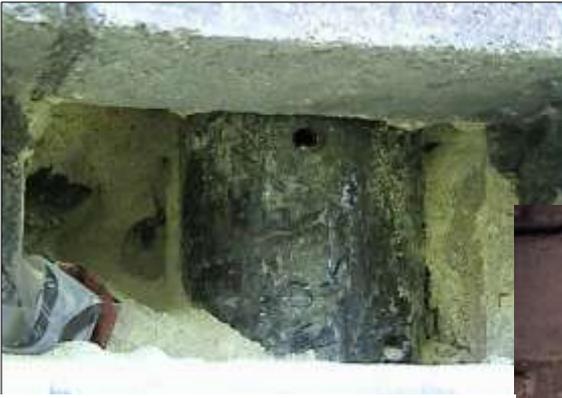
In these unique views the black pitch fibre downpipe can be seen emerging from the encasing mortar which holds it in place within the cavity. The solution adopted was to entirely encase the collar in (I think) a version of roofing felt and any standing water in the pipe would not then

be able to find its way out into the brick. The contractors estimated a min. 30 year lifetime for this repair and certainly halfway through this period no further leaks have been seen.

The bricks were replaced and a matching pointing used and the repair has left no signs of where it took place.

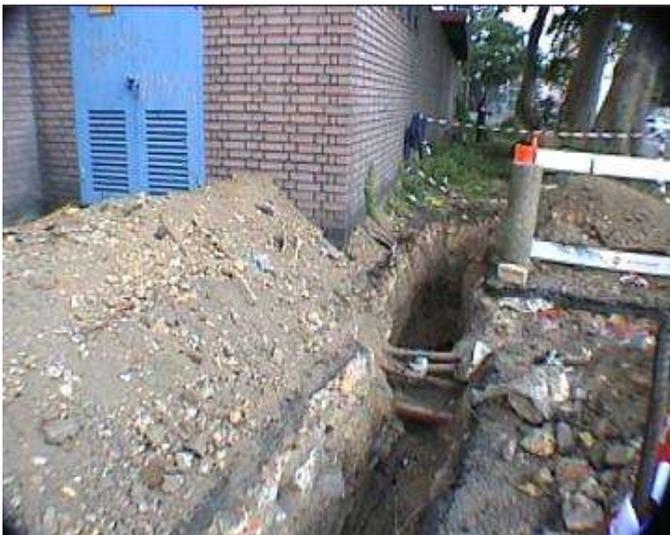
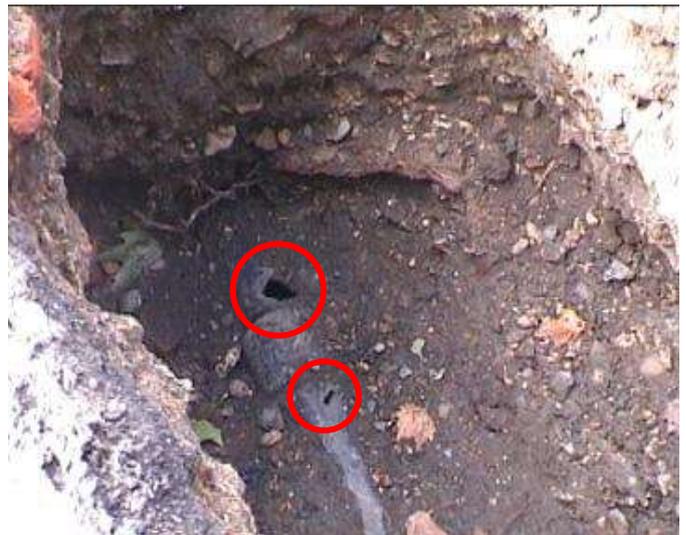
In September 2001 a section of underground drainage was then investigated along the south side of the church hall under the enormous plane trees which have stood there probably since Victorian times. It was clear that the tree roots had caused problems with the drains and particularly with a material as easily compromised as pitch fibre. As can be seen from the image below, just in this

small section the pitch fibre had been perforated and almost certainly deformed or damaged elsewhere over a period which now well exceeds its useful maximum lifetime of 40 years or so.

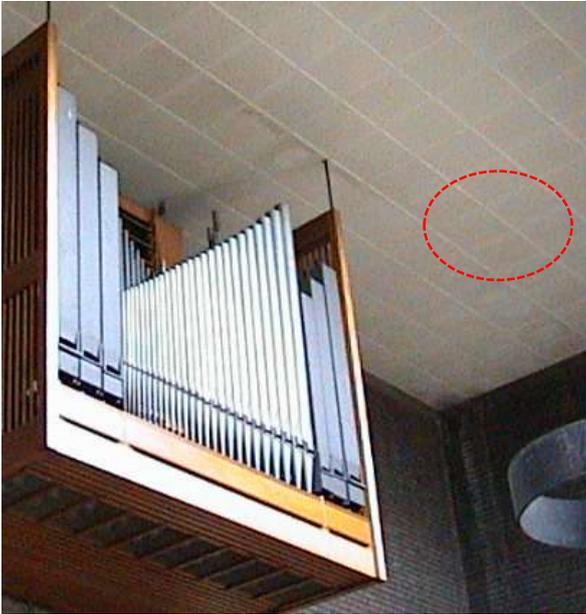
Meanwhile, some time before these works began early in 2005 a ceiling tile came loose in the circled area shown in this view and was hanging by one edge. With the underlying area of seating cordoned off beneath, the tile was examined with a view to being re-fixed. To our dismay it was then discovered that all the acoustic tiling at high level contained **asbestos**! This was known from the beginning but never passed down – indeed, the drawing of 1962 on the next page details 'asbestos facia.' However, when the use of asbestos was banned in 1985 this knowledge was not passed on nor measures taken.

It was the highest priority now to remove and replace the whole of the inner ceiling of the church as well as to renew the whole of the outside high level flat roof! And no funds were allocated for this with the grant deadline about to run out and insufficient funds! Oh the joys of being an Incumbent!

Mercifully, English Heritage allowed us to divert the funding element which was earmarked for sealing the 14 lower level downpipes now towards replacing all the asbestos ceiling tiles. And we made the deadline! Effectively, the church high level flat roof was now going to be renewed externally and internally as well as leaking rainwater goods (all in pitch fibre) repaired and/or replaced. For many weeks the church was submerged in darkness as it was completely filled with scaffolding and boarded over for access to the whole of the inner ceiling and also for repairs to the lantern.

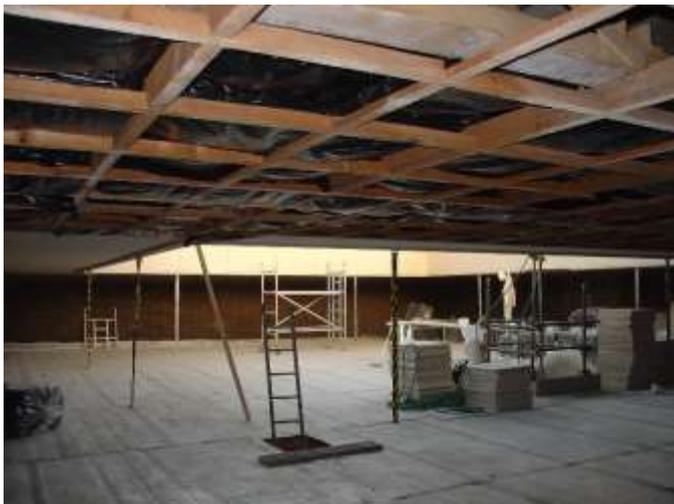
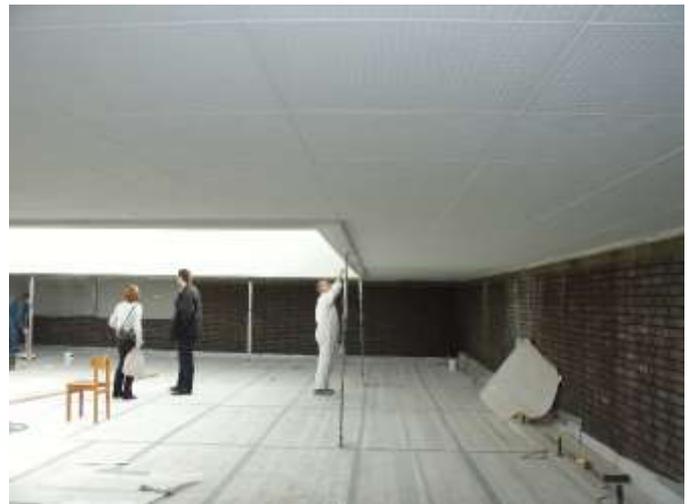
As the ceiling tiles were removed it was clear that there had been years of damp caused by water penetration through the failed upper flat roof asphalt and through leaking pitch fibre rainwater goods at that level.

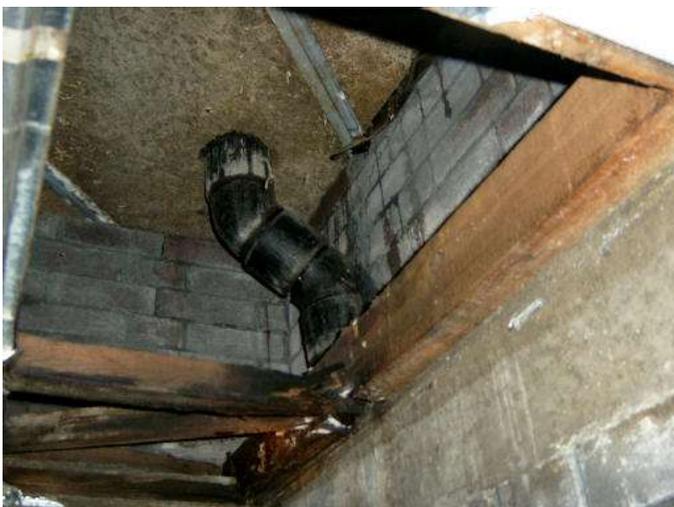
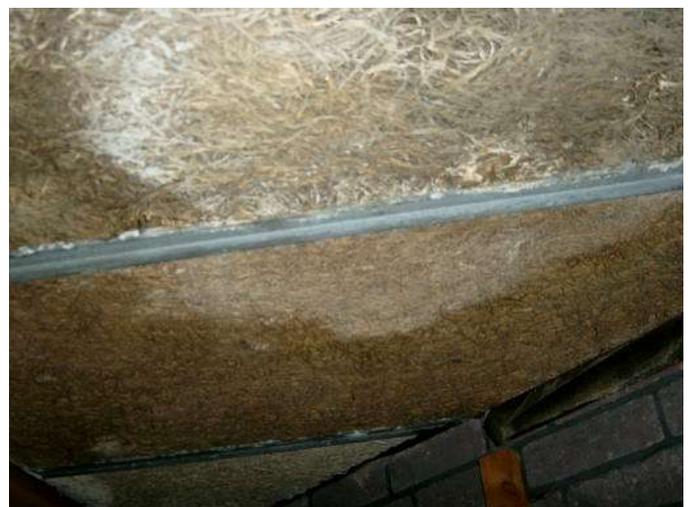
Because of the failure of the upper flat roof and leaking rainwater goods, clear signs of damp can be seen. Repairs to both have put a stop to this and damp areas have dried out.

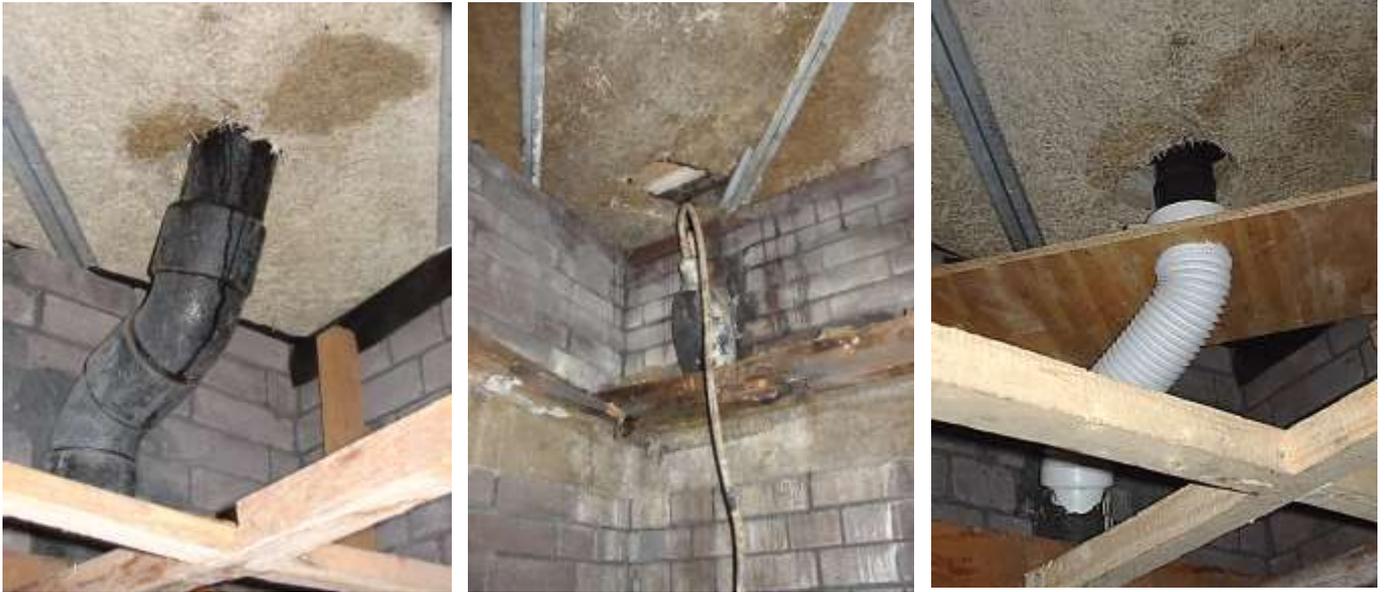
A pitch fibre connecting pipe from roof rainwater inlet into one of the long down pipes sealed in the corners of the upper brick walls below the lantern. Clear signs are visible that these have been leaking. Modern durable flexible plastic replacements were installed and sealed.

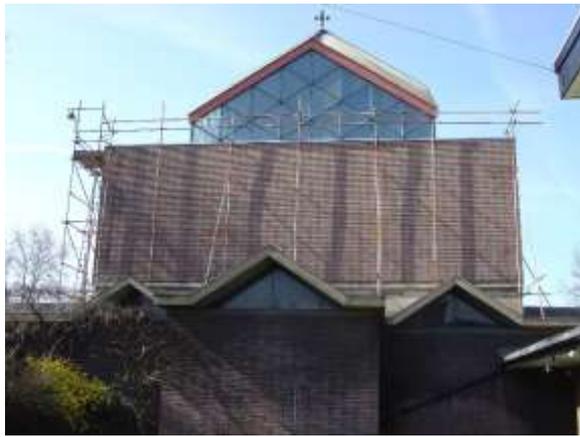
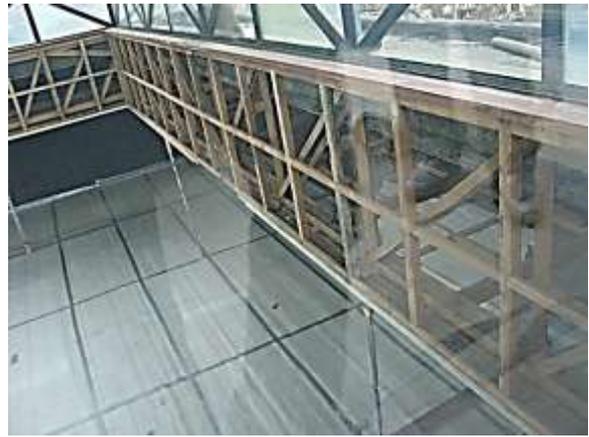
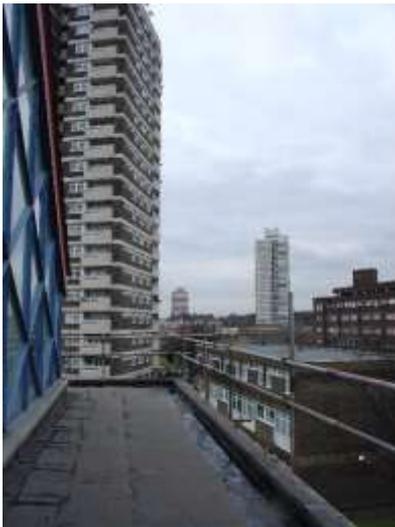
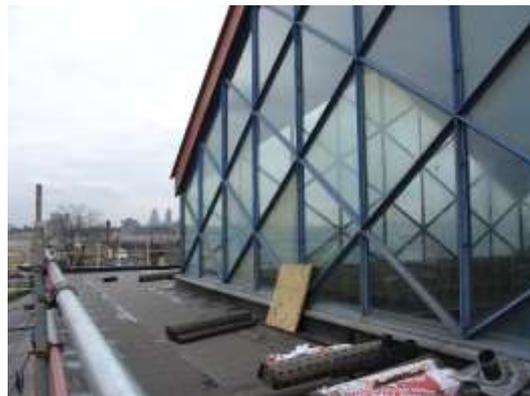
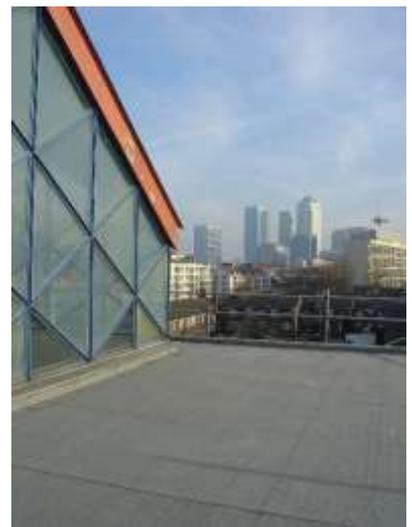
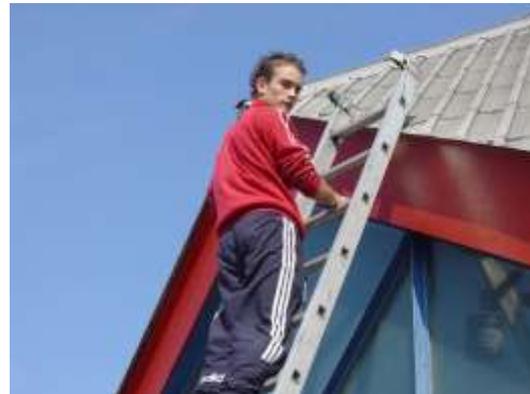
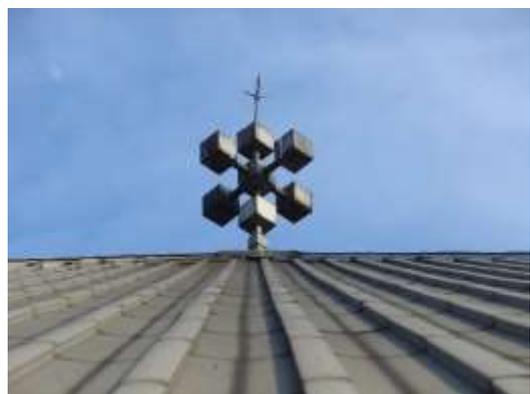
From ground level we had thought that the high level lantern fascia had faded paintwork but close inspection showed decay, as can be seen. All of this was renewed and the 'signature' 'bull's blood' colour of the porch lettering (and possibly, originally the foundation stone?) refreshed at this level, as had been originally when the church was built.

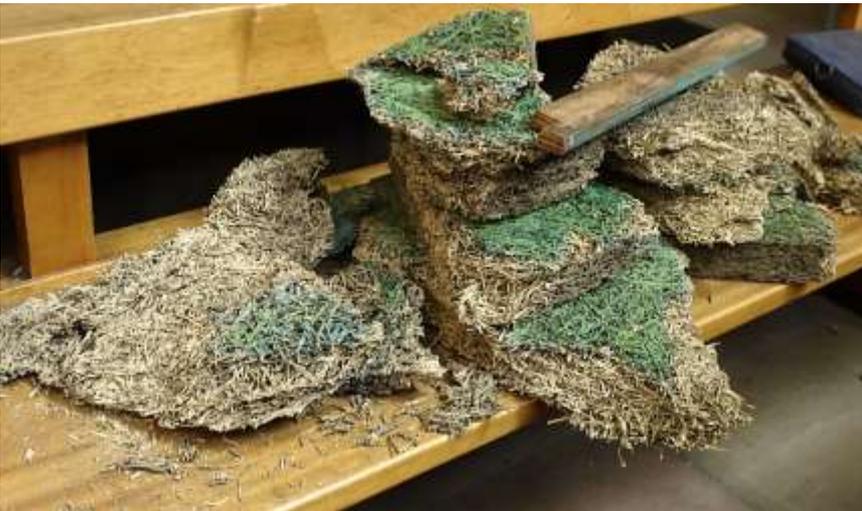
The large pieces of woodwool which fell out of the lantern stacked on a bench after the event. The water stained wooden spacer which also fell showed a vital clue to damp having been present up there.

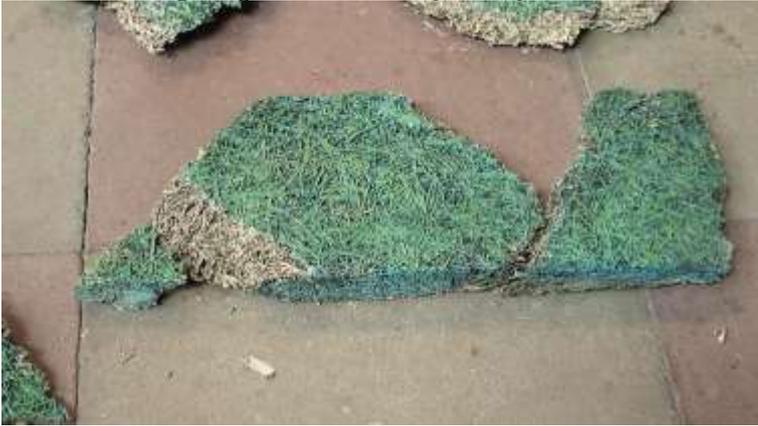
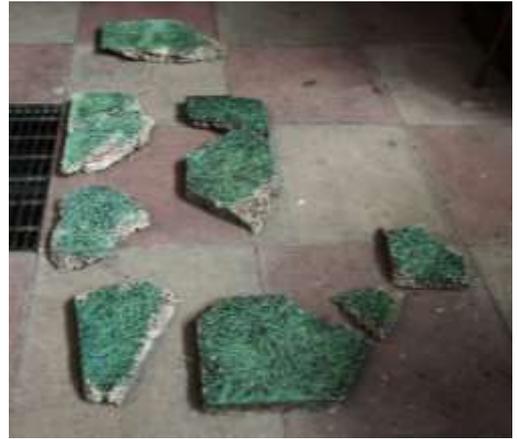
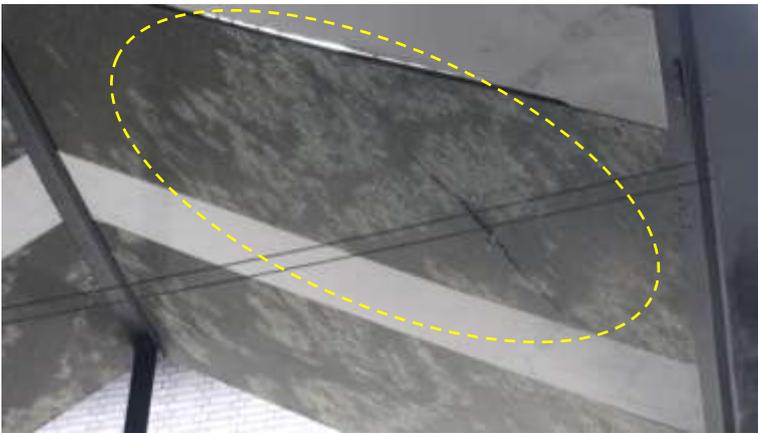
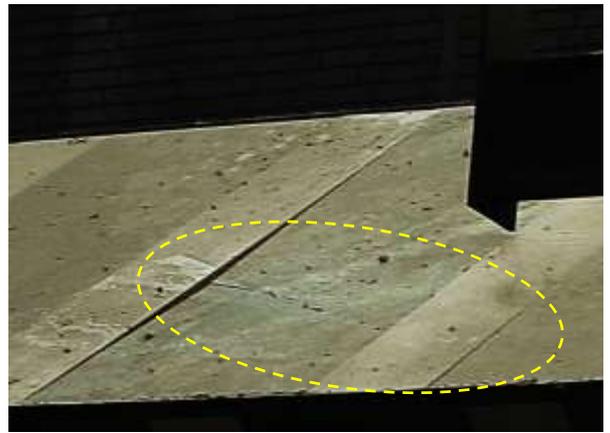
These images show how some of the largest woodwool pieces had originally fitted together and also the crack in the slab of serpentine on the ciborium roof, shattered by the impact and which, by holding and not collapsing inwards, very likely saved life and safety.

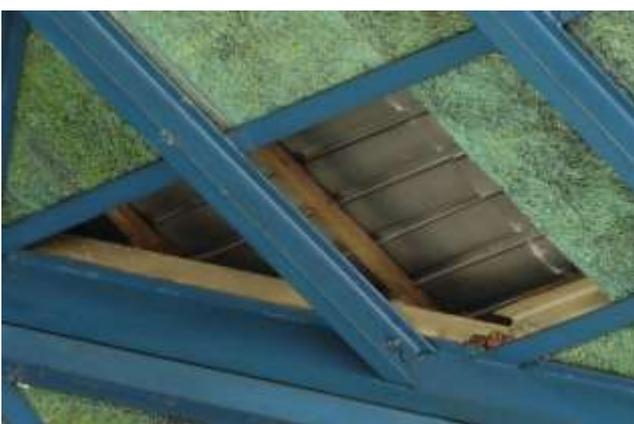
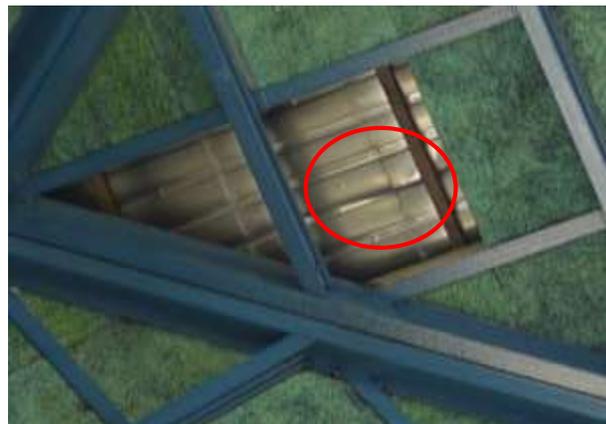
The left hand view above seems to show just plain aluminium roof covering. But when seen from a more north-easterly point clear damage can be seen to the overlying aluminium roof skin. If that damage had been such that water could have penetrated into the woodwool in that region, it is a very inflexible concrete-based material with little give and if the woodwool swelled it could have applied considerable pressure upon adjacent slabs. The water stained hardwood wedge which fell clearly shows that in that region there had been water penetration,
