Overview of Section D

The present church of St. Paul's, Bow Common

Repairs and revelations:

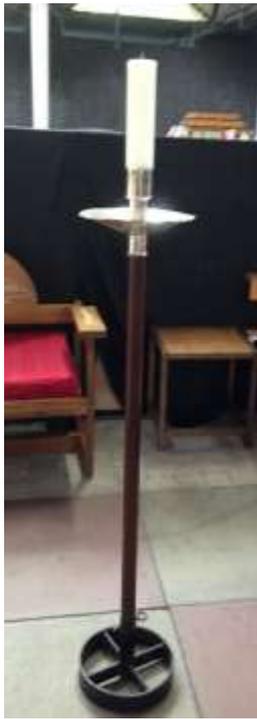
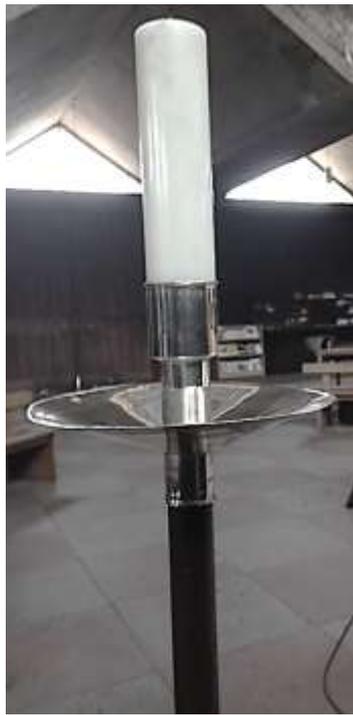
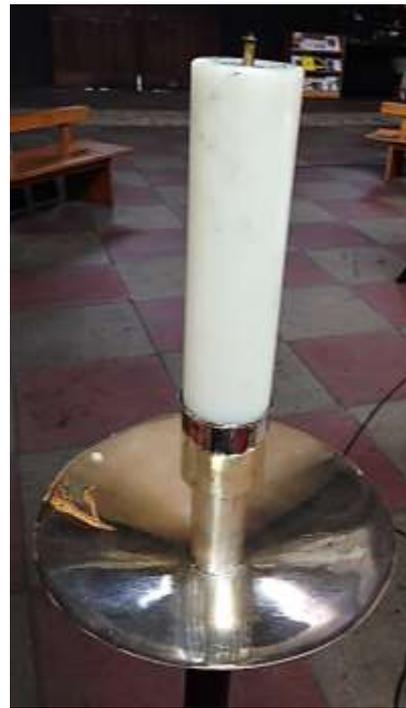
Sconces

Over the years the sconces had been dropped and knocked and dented and came to look quite battered. They were therefore restored very carefully just before the 50th Anniversary Celebrations in 2010.

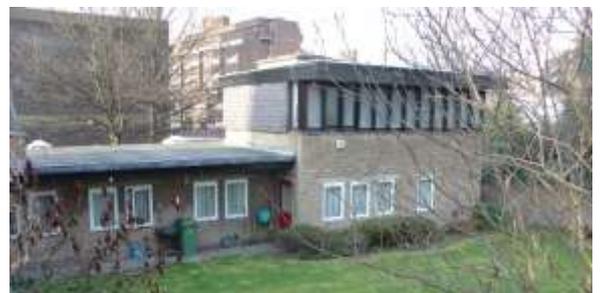
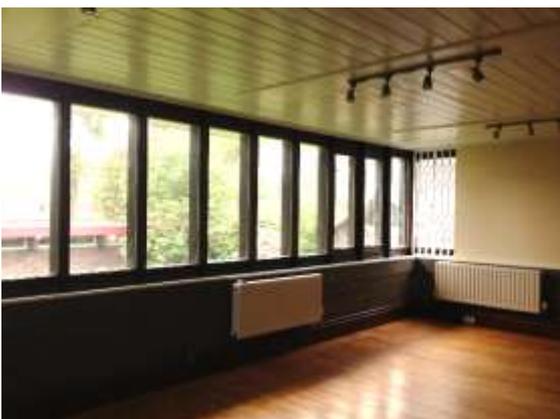
It is not built to the same standard of brickwork as was the church. No attempt was made to match the colour of brickwork or the quality of bricklaying. It was a very cold place in which to live when

In terms of security it was designed with easy access to the flat roof, either from the low boundary walls or from across the lower folded slab roof of the church. From what I heard, even in his old age Fr. Kirkby was troubled by youths climbing into the garden and banging on his windows. On the first day of my moving in, someone broke the study window to get in but had not reckoned with the bars installed on my arrival! In

2010 there were 8 separate attempts to steal lead from the flat vicarage roof – the only place in the whole church site in which there was lead. The front door is also rather isolated and there were incidents there in my time. Security fences, lights, alarms and cameras provided more security.

I arrived in the parish but after a few years the large flat roof over all the bedrooms was insulated and the windows were double glazed in the large upstairs sitting room and this improved matters noticeably.

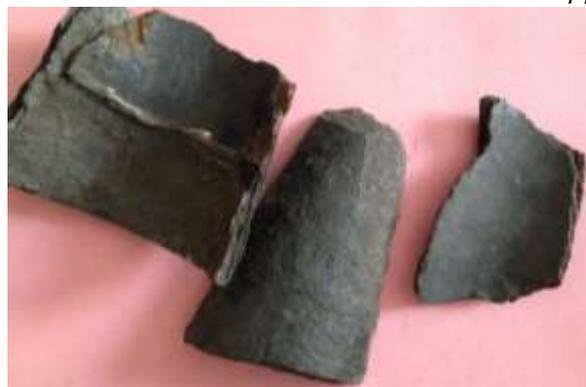
'Pitch fibre pipes were mostly used from the 1950s to the early 1970s. They were British Standard approved (BS2760), although this was withdrawn on 15 June 1987. The pipes were relatively inexpensive and easy to handle and install. However, it became apparent that these pipes were susceptible to the delamination of

their inner surface, ruining the integrity of the pipes. It was also discovered that, under normal conditions, they were susceptible to collapse under applied loading sooner than pipes made of more rigid materials.

Published figures suggested that if laid correctly, and not subject to adverse ground conditions, pitch fibre pipes can be expected to have a design life of up to 40 years. This means that many of them have reached or passed their design life expectancy. If poorly installed, the life expectancy would be significantly shorter.

'as they arise. Pitch fibre will 'squash' over time.' The principal cause of failure in pitch fibre pipes is as long term creep failure of the material. This phenomenon is normally caused by point loading from hard objects due to poor construction; or loss of side support. Pitch fibre pipes are also highly susceptible to damage by high pressure water jetting.' Documented 2003

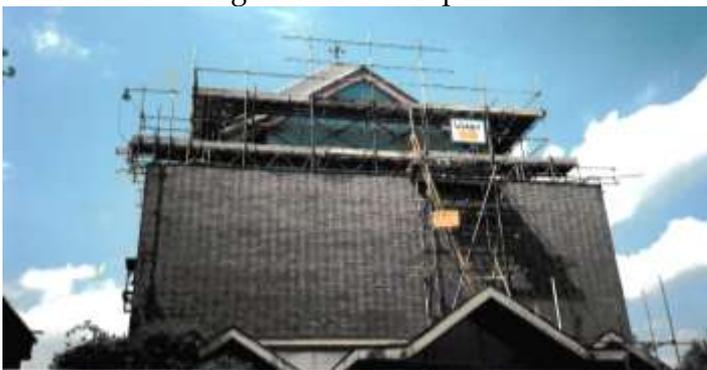
scaffolding erected for these works to be done.

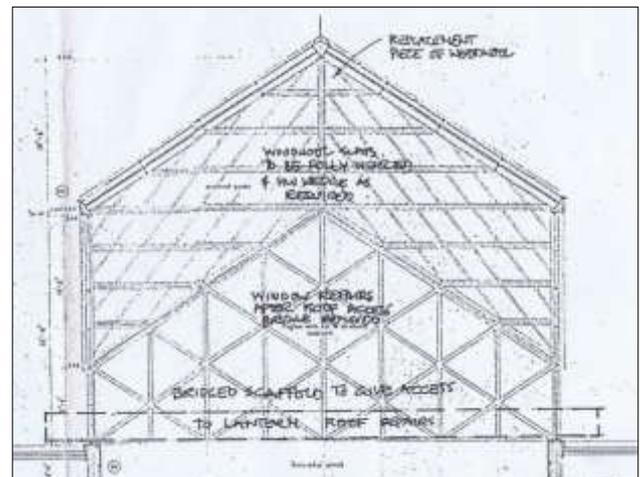
This section of the architect's drawing of 1991 for repairs to the storm damage (right) shows that a 'bridged scaffold' appears to have spanned right across the base of the lantern and also outside, to give access to the lantern roof repairs. The tiny detail at the top, 'Replacement piece of **woodwool**' proved to be vital evidence in trying to understand woodwool, a material which came to dominate the church's life from mid 2013 to late 2015! See later.

Some of us remember the hurricane of October 1987 which hit southern England and caused a huge amount of damage, including that inflicted on the church lantern with large glazed panels blown in. Again, with the support of English Heritage, these and some roof damage were repaired in 1991. This view shows the lantern with

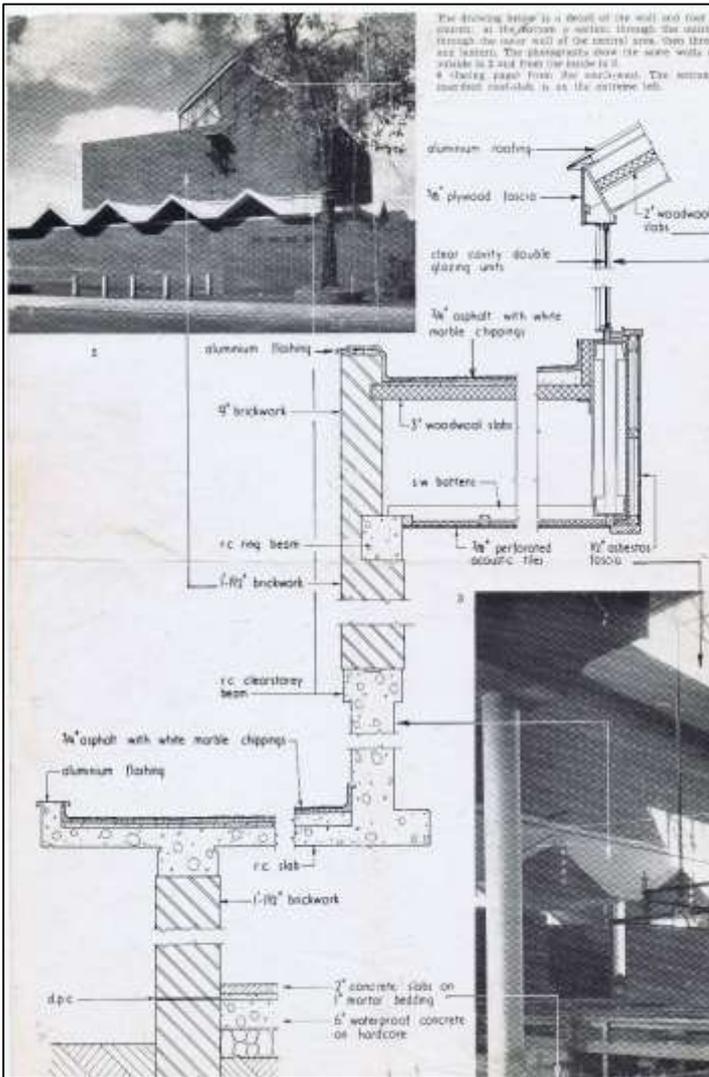
'This image (left) from 1962 shows the architectural detail of the upper level of the church. Although the acoustic tiles are not specified as containing asbestos, the fascia at the base of the great lantern space clearly is stated as being '1/2" asbestos fascia'! This paper had obviously not been scrutinised in detail since it was published, at least in the years up to when asbestos was flagged up as needing to be removed and replaced.

What also appears in this detailed drawing is 'woodwool.' I had long known that the green 'lining' across the whole of the inner of the lantern was woodwool but beyond a passing curiosity never thought to discover more about this material.

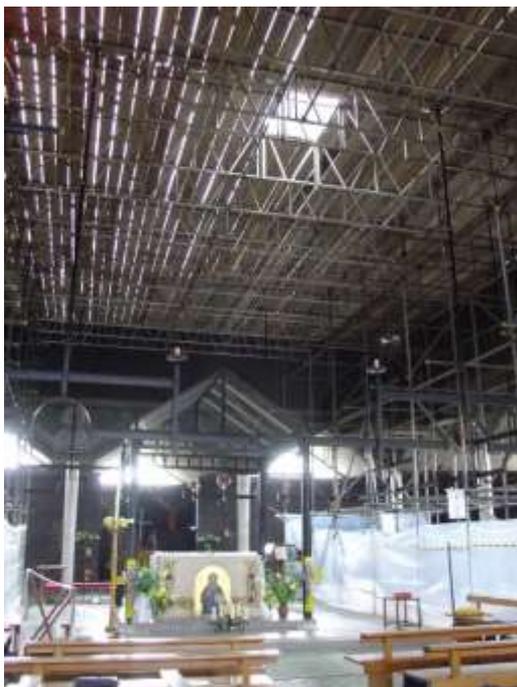
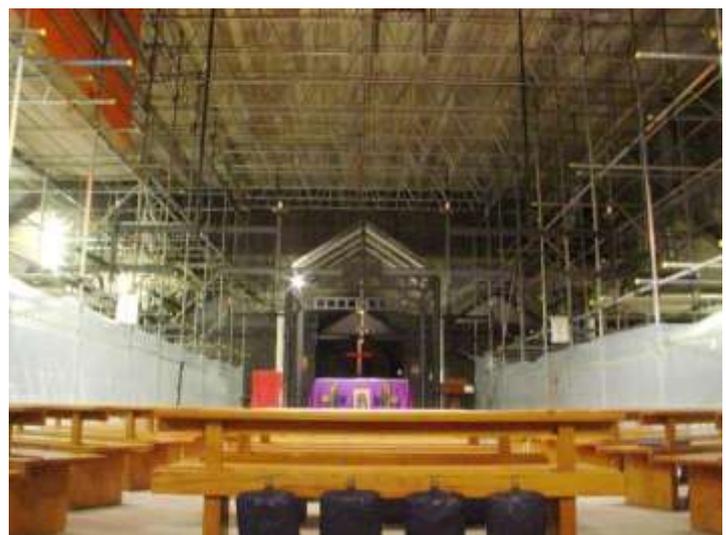
The darkened church filled with scaffolding

The platform beneath the lantern with the roof space revealed above and all the asbestos ceiling tiles removed.

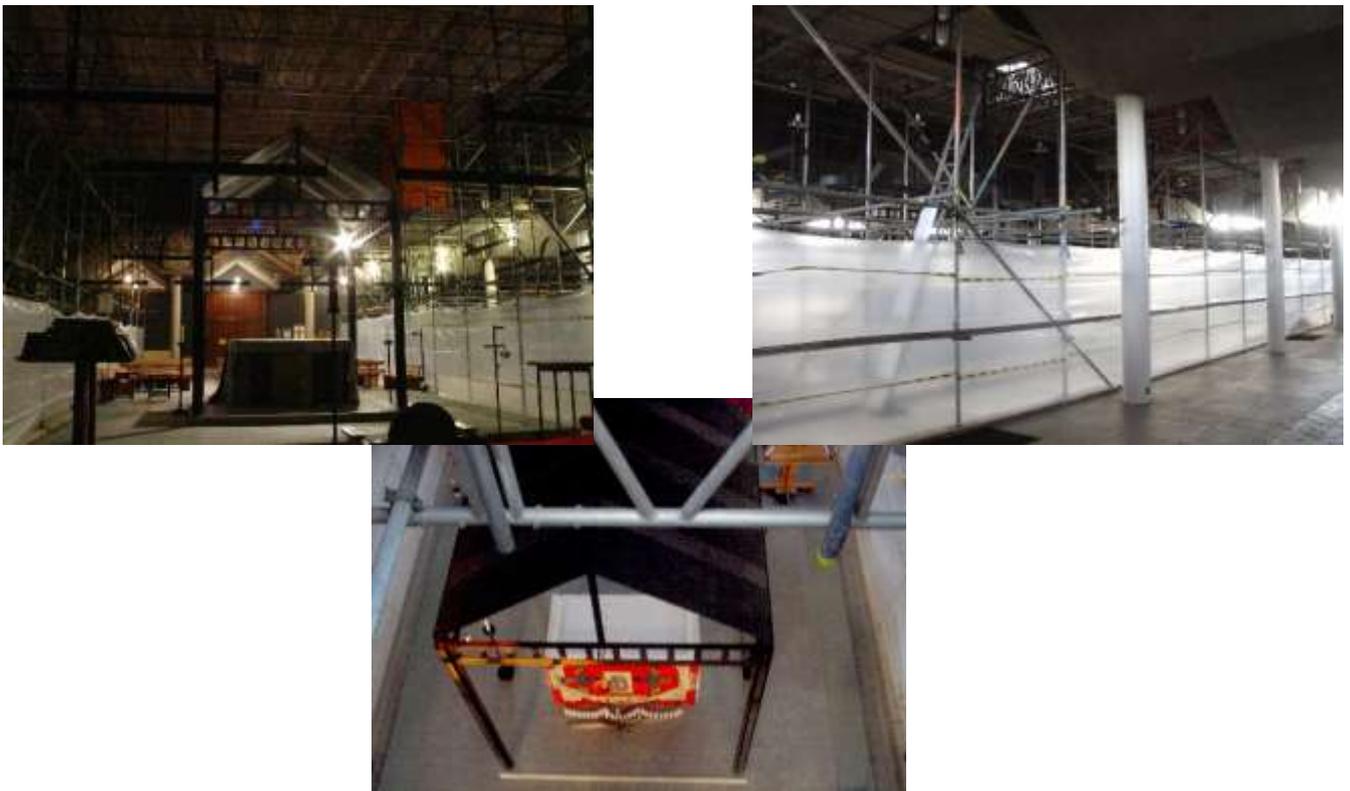
Meanwhile, exterior works were carried out to the leaking upper level flat roof. While all this was going on, as seen, the church, usually bathed in light, was plunged into an unfamiliar darkness.

The upper flat roof surface was totally renewed and that, in conjunction with the renewal of rainwater goods within the roof space hopefully ensures a church without leaks and water ingress at high level for the first time in decades and for many years to come.

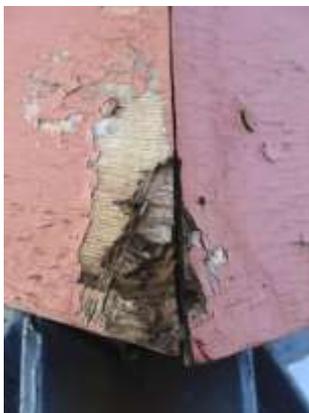
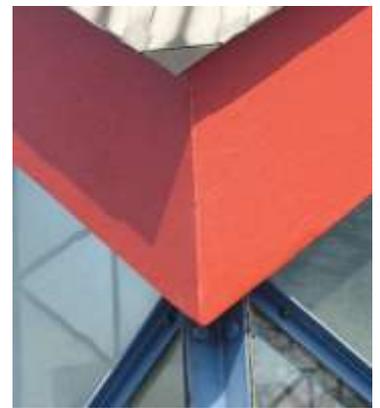
From ground level we had thought that the high level lantern fascia had faded paintwork but close inspection showed decay, as can be seen. All of this was renewed and the 'signature' 'bull's blood' colour of the porch lettering (and possibly, originally the foundation stone?) refreshed at this level, as had been originally when the church was built.

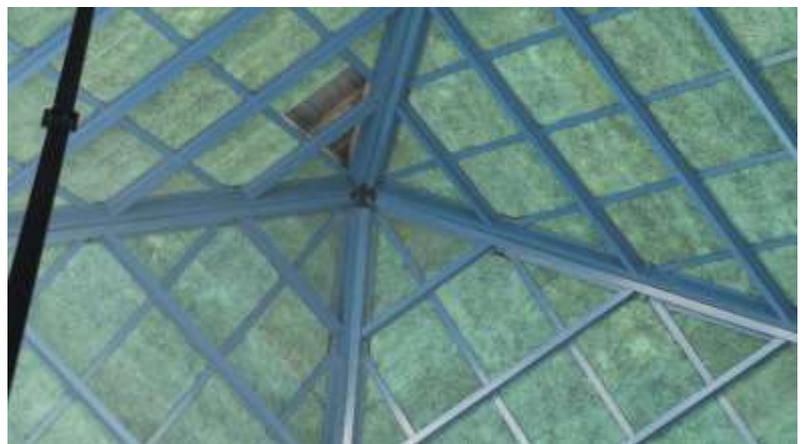
It slowly emerged, as we looked up to the pinnacle of the lantern that some slabs of woodwool had chosen that precise moment to detach from the top of the lantern and crash exactly and directly over where I had been standing at the altar. The slabs had hit the marble and serpentine panels of the ciborium over my head and, thankfully, these had held fast. The stone panels had split as the now shattered fragments of woodwool shot sideways – southwards, directly towards all those standing at the altar step and in their path. The noise of impact had provided the vital split second warning for them to leap out of the way. Had the marble slabs not held but collapsed on top of me, or had the young people not had a fraction of a second's warning, the consequences would have been unthinkable.

I honestly thought that missiles had been launched at the lantern from outside and had crashed through the glazing. As the dust settled we could see large heavy pieces of green coloured, sharp-edged debris lying around, exactly where the young people had been standing moments earlier and a great deal of dust and fibrous matter all around. I had never thought at all about what exactly the '**woodwool**' was, which lined the inside of the green coloured lantern roof interior. It sounded a bit soft and fluffy – some sort of

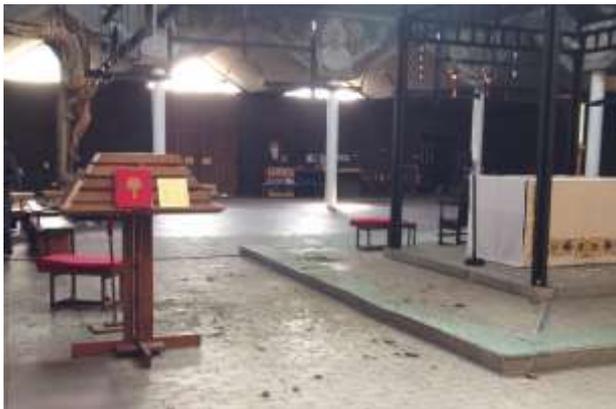
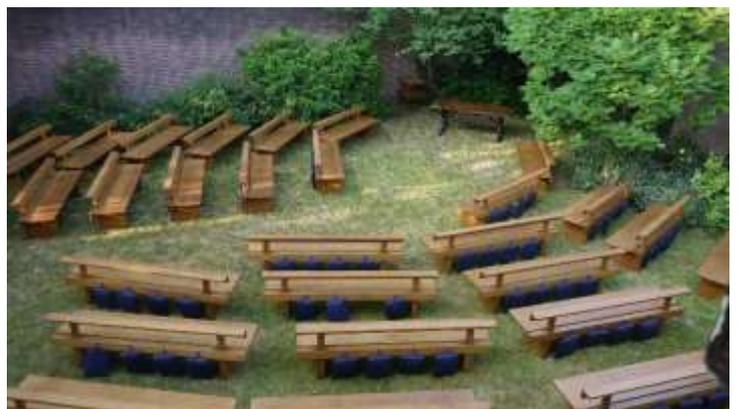
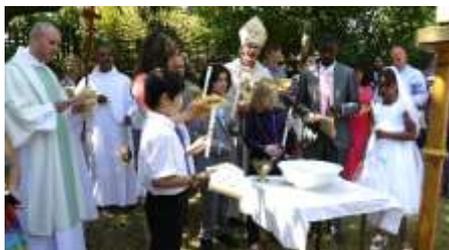
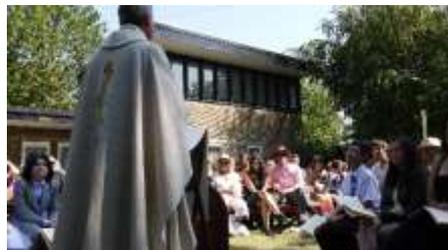
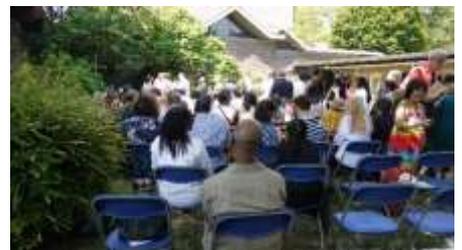
The spirit of the people of St. Paul's, Bow Common was undaunted and immediately all the church seating was removed from the church to the Vicarage garden to create an open air church for what turned out to be a most memorable Confirmation service with 300 people present the next morning. We were in a heatwave and the weather was perfect and demonstrated powerfully that, as wonderful as our church building is, the heart of a church is not bricks and mortar! Maguire and Murray were right when they said that the church did not **need** buildings!

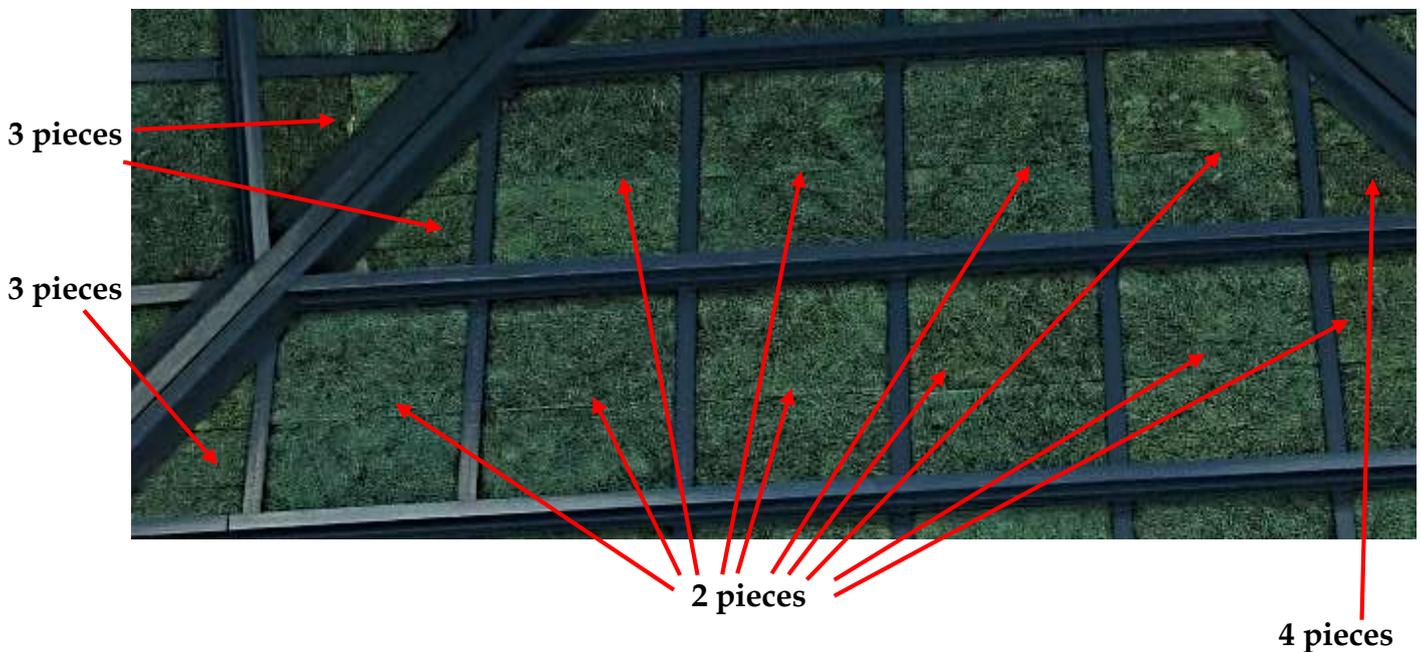
I learned a lot about woodwool from one of the contractors who attended after the roof fall. It seems that woodwool is at its best and most stable when used in large blocks, typically of 2-3 m in length. What we see in the church lantern is a patchwork configuration of smaller pieces where possibly larger and more stable single large pieces might have been safer for use. There is a framework of I-section metal girders which make up the grid of the lantern roof. The woodwool slabs were laid on top of the flanges of the beams from above before the aluminium roof tiling skin was fitted on top. Thus the woodwool pieces were laid basically loosely and not secured but held up by the girders. There were 160 spaces to be filled but from my observation 355 separate pieces of woodwool were used to fill these spaces. This complicated looking image illustrates this point.

14 spaces here have been filled using 33 woodwool slabs.

However, on close inspection of the individual slabs it can be seen that some of them were very possibly cut short. From his knowledge of wood-wool, the contractor spoke of the potential instability of smaller pieces of the material (especially when not fixed down) when subjected to forces of wind or heat expansion or water. In his experience, any disturbance of the 'safety blanket' of aluminium tiles above can lead to air or wind disturbance of the wood-wool beneath, especially if not laid in large slabs and woodwool will 'move'. Smaller pieces are much more vulnerable. I also did a thorough investigation of how each piece of woodwool was being supported at the edges and **only 2 pieces out of the total of 355 are supported on all edges**. The remaining vast majority of woodwool pieces have no perimeter support on at least one edge.

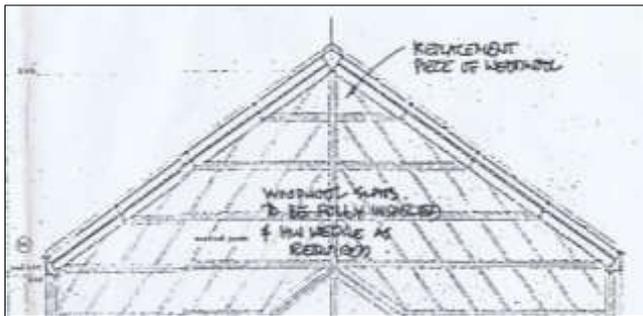
The problem had a long history and there had, therefore, been a mechanism at work early on, which resulted first in small blocks falling from the apex. Woodwool blocks had shrunk and settled. Since none of the blocks is fixed they all rest one against the other. As shrinkage progressed so they all effectively shifted downwards. This then dropped the composite triangular sections at the apex downwards into spaces which were too big for them. They then fell to the ground. There is no

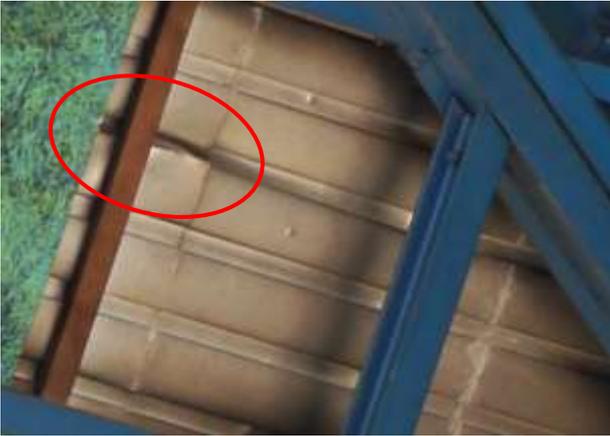
The left hand view above seems to show just plain aluminium roof covering. But when seen from a more north-easterly point clear damage can be seen to the overlying aluminium roof skin. If that damage had been such that water could have penetrated into the woodwool in that region, it is a very inflexible concrete-based material with little give and if the woodwool swelled it could have applied considerable pressure upon adjacent slabs. The water stained hardwood wedge which fell clearly shows that in that region there had been water penetration,

to judge by the staining on it when clean unstained wedges would initially have been installed. Woodwool cannot bend but its ultimate response to stress would be to fracture. Mention has already been made of this being a very hot period when the woodwool fell on 6th July 2013 and I remember clearly how hot the pieces felt when I first picked them up immediately after the roof fall. Thus, had there been a scenario of water, somehow soaking the woodwool through that area of damage to the protective aluminium outer skin, and then over perhaps a long period of time swelling through further soaking and also baked in summer heat under the metal skin, it is reasonable to imagine that eventually the stresses on such an unaccommodating material could have led to sudden fracture. Once a piece of woodwool fractured there would be nothing underneath to keep it up in the lantern and it and everything else unsupported around it would then fall to the ground.

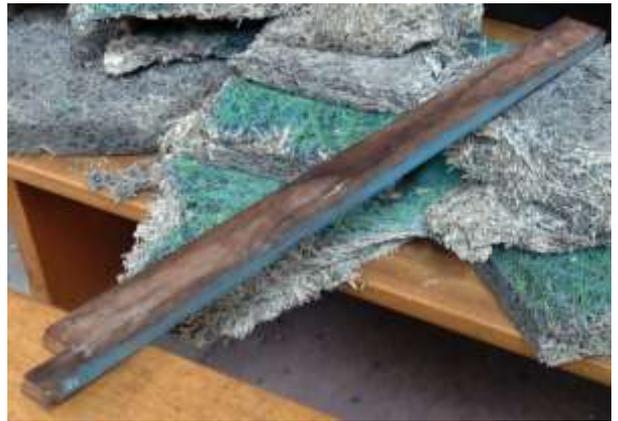
This seemed to be a reasonable explanation of why the woodwool had fallen suddenly out of the lantern – albeit with extraordinary and almost perilous timing! The point was not lost on me that no-one was hurt and the marble roof and weight of woodwool did not collapse onto my head, and that had this happened the next day during the crowded Confirmation service with the bishop in exactly the wrong position the possible outcome would not bear thinking about. If there was some kind of woodwool clock ticking away then we were extremely fortunate!

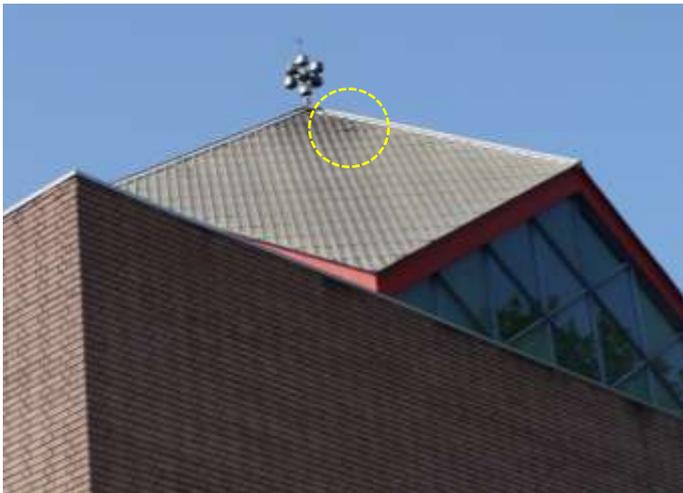
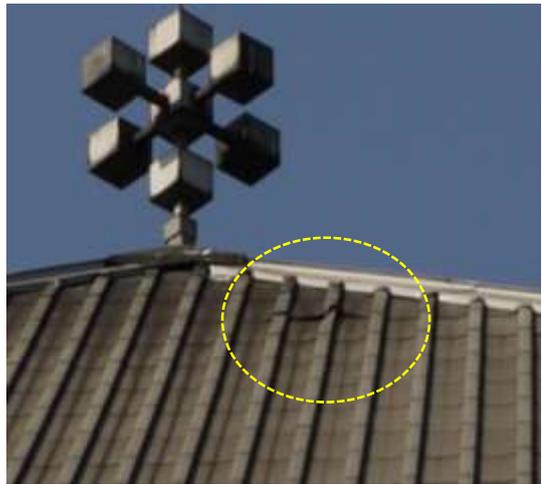
The question then remained of how damage could possibly have occurred near the apex of the lantern where nothing and no-one has been since the roof was laid in 1959. Immediately on inspecting it from the outside, the area where the woodwool had fallen on the inside, a tiny bit of damage could indeed be seen! It is so small that it entirely escapes the eye unless looked for.

It now looked very much as if a mechanism could be found to explain what had happened. But the question remained of how this damage to the outer roof could have happened and when.

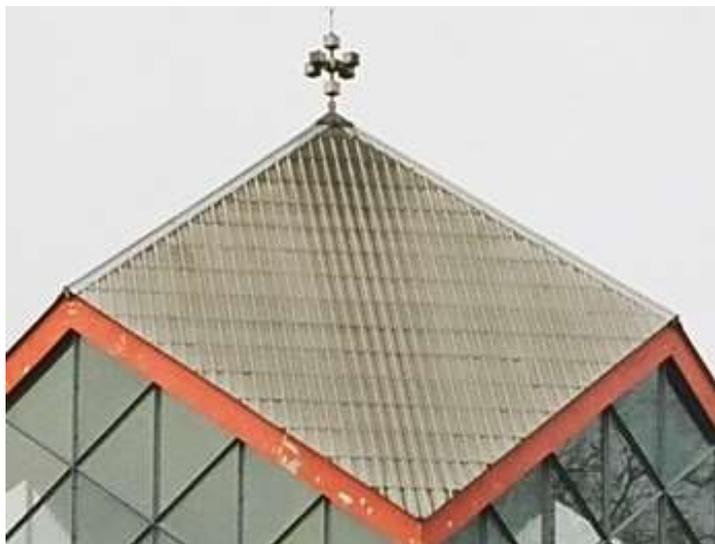
In 2004, following 6 years of using the inside of the church for art and community events, an extraordinary artist, the late Rose Finn-Kelcey, installed a huge art work on the upper west face of the church, below the lantern, with 850 sq ft, of dazzling shimmer disks in the award-winning installation, 'Angel.' This work was extraordinarily popular and had an extended period of viewing on the church from February to July of that year. I logged every stage of its installation, which meant that I had more views than I would normally have of the outside of the church. This view (left) is from

the day on which 'Angel' was installed - 20th February 2004. This is of the face of the lantern roof where the damage was identified and it is very clear that the aluminium roof facing is **undamaged!**

On further close searching of my images it is clear from this later view from 2nd April (see right) that **damage has now occurred** - and the dent is visible in the external aluminium covering. One would conclude that whatever caused it must have taken place between 20th Feb. and 2nd April 2004.

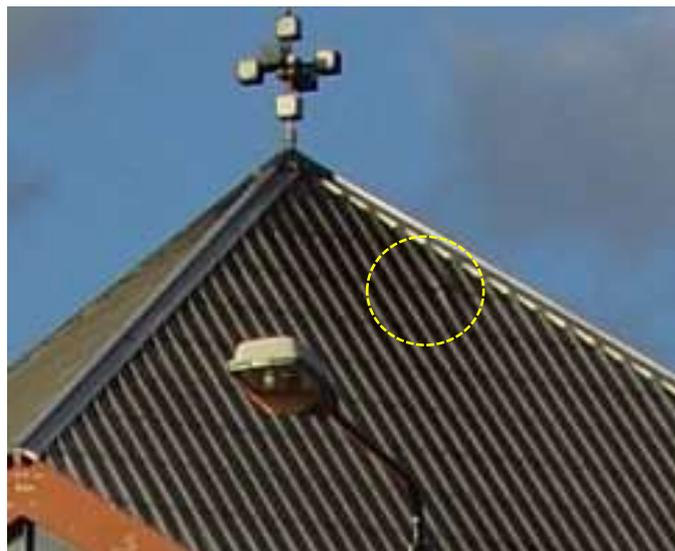
And then, purely by chance, I noted some curious images I had taken that March of debris in the Vicarage garden! As shown here, large pieces of debris - looking like builders boards and planks - had been blown by a gale into the garden during the night of 19-20 March 2004. The winds had been severe and strong enough to lift or to remove these

large pieces of timber from wherever they had been, very likely over rooftops, to drop them into my garden. If large pieces of windborne debris were flying high on that night it is quite feasible to propose that something heavy and large enough to dent the aluminium roofing may have been blown against the roof that night and caused the damage. Weather records confirm that southern England suffered severe gales on that day. The dent looks very much as if something has impacted from below. Perhaps the mystery has been solved, in the absence of any other explanation so far!

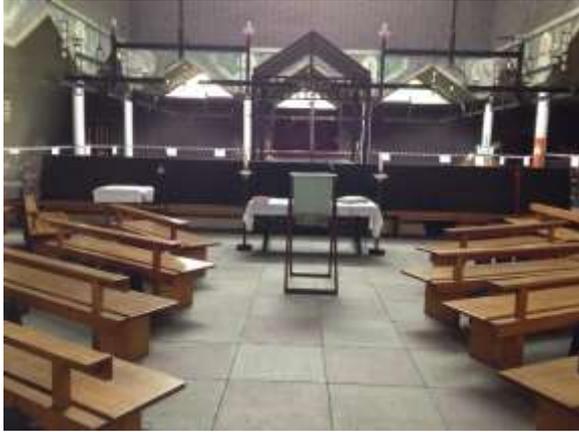
From 6th July 2013 the greater part of the church has been cordoned off beneath the 'footprint' of the lantern above. I was never again to stand at the high altar. Once the congregation had been given the go-ahead to return to using the main building a safe area was set up westwards of the central space which up to the time of writing this account (Summer 2015) has been the effective useable area of the church. Again, the extraordinary flexibility of the building has made this possible without too much trouble and all aspects of church life, from services to Christmas Bazaars and some community events have continued.

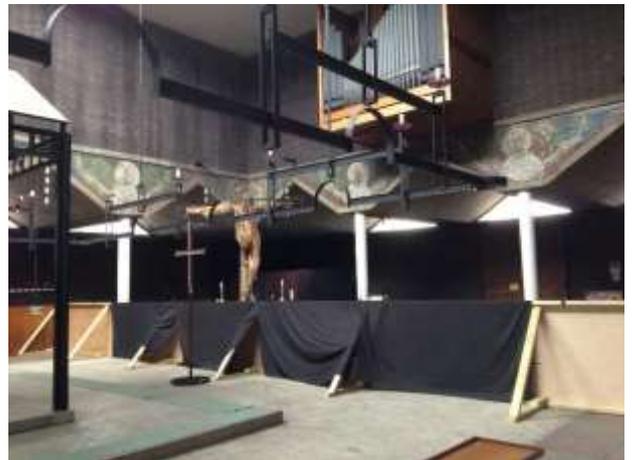
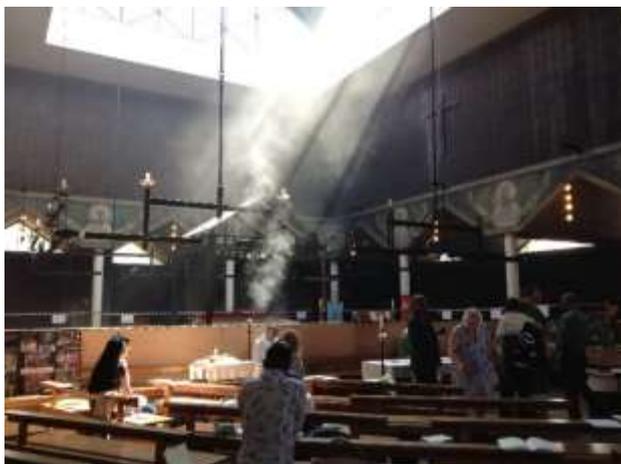
Reflecting on the particular history of woodwool in the church lantern from its original installation I feel confident that as long as the crucial protective aluminium skin of the Hyrib 'skin' maintains its integrity and suffers no further damage there is no reason to expect further falls of woodwool from the lantern. Settling and shrinkage has very likely now stabilised after more than five decades and following the close inspection of the whole woodwool configuration in 1991 and insertion of hardwood spacers, so long as water penetration does not take

place, the whole system should remain stable. The discolouration of the green painted surface of the woodwool could be due to condensation and that has always to be taken into account in any assessment of the woodwool's integrity. There is no ventilation in the church and on hot summer days with high humidity perhaps added to by people in the church there will be moisture in the air.

From 2014 stirring efforts were made by the church to manage a building project and raise funds both for the inspection and repair of the woodwool in the lantern and also finally to re-lay the whole of the drainage system for the church with modern materials. **Mother Bernadette Hegarty** came to the parish as Vicar on 4th October 2014 and is seeing this all through to completion, with works starting in Autumn 2015 and coming to completion, hopefully, the following winter. I understand that the fallen woodwool is to be replaced with new woodwool slabs and all the remaining slabs secured to the metal framework of the lantern. St. Paul's, Bow Common should be at its 'healthiest' and driest as a
